SIGAR

Office of the Special Inspector General
for Afghanistan Reconstruction

November 14, 2016

THE HOTEL IS UNFINISHED AND APPEARS TO BE ABANDONED

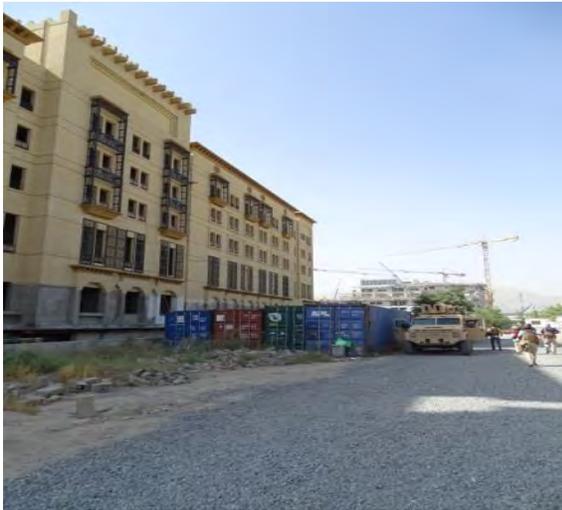
Photo 1 - Exterior of KGH

On August 1, 2016, SIGAR inspectors visited the hotel to determine the status of the project. We found that the project was never finished and appears to be abandoned.⁸ We found structural cracks in the walls and roof; damaged fireproofing on steel beams and columns; demolished wall sections; incomplete electrical, elevator, communications, fire prevention/suppression, sewer, heating, ventilation, and air conditioning systems; unfinished concrete masonry units; uninstalled doors and windows; and, many other problems. Photos 1 through 6 show the interior and exterior condition of the KGH at the time of our site inspection and my recent visit of October 29, 2016. Based on our inspections it is clear that the assurances made to obtain the final loan disbursement were false and misleading. We are currently determining whether earlier representations made to justify the prior disbursements were also false and misleading.

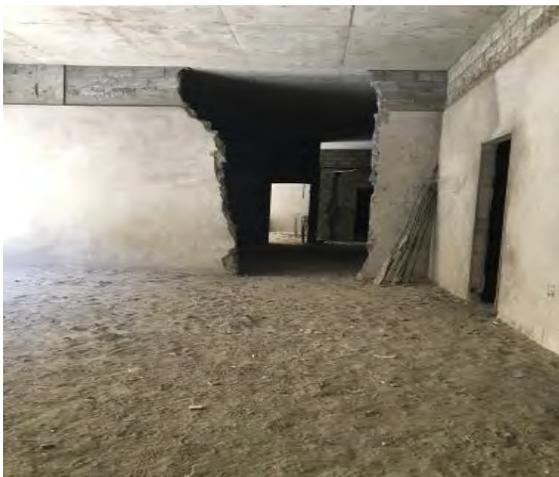
Photo 3 - Basement Interior of KGH

⁸ The large quantity of construction debris, crates of stored materials overlaid with thick layers of dust, and lack of any construction lighting were clear indications that the buildings had been abandoned.

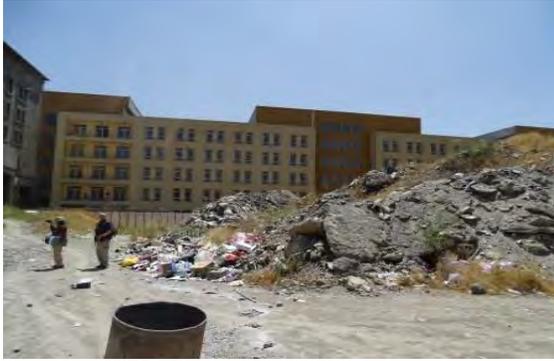
Photo 7 – Exterior of KGR

SIGAR inspected the site on August 1, and again on October 29, 2016. As with the hotel, we found that the apartment project was never finished and appears to be abandoned, and that representations made to OPIC that the building could open by August 2013 were blatantly false and unrealistic. We found structural cracks in the walls; incomplete electrical, elevator, communications, fire prevention/suppression, sewer, heating, ventilation, and air conditioning systems; uninstalled doors and windows; and, many other problems. Photos 7 through 12 show the interior and exterior condition of the apartment building at the time of our site inspection.

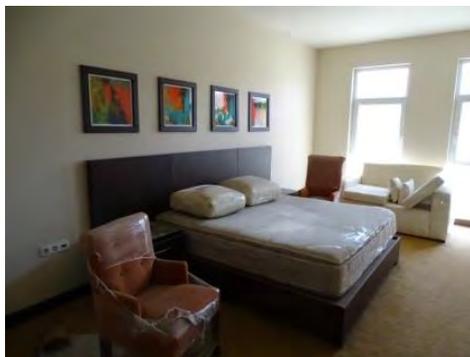
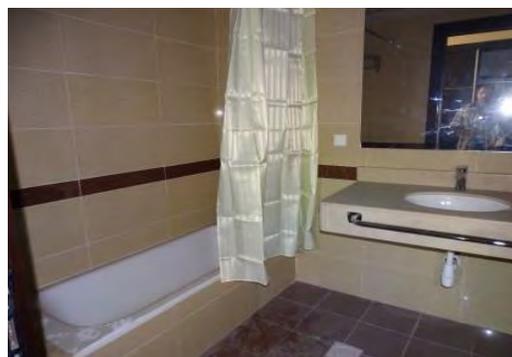
During our site inspection we also found that two rooms in the building appeared to be model rooms intended to demonstrate what completed residences might look like. Superficially, these rooms looked to be complete, but in fact they had none of the basic infrastructure necessary to make them habitable (i.e., electricity, water, toilets, air conditioning, fire alarm, etc. were missing). The contents of the rooms were covered with a thick layer of dust. Photos 13 and 14 show these model rooms.

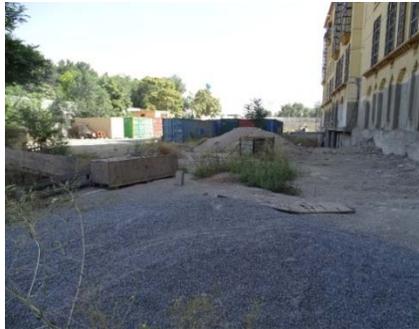
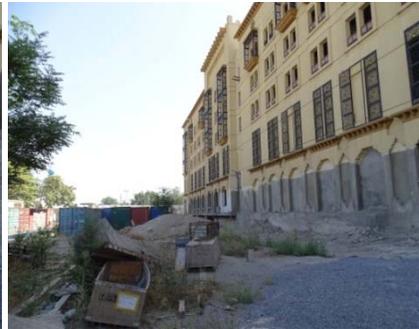
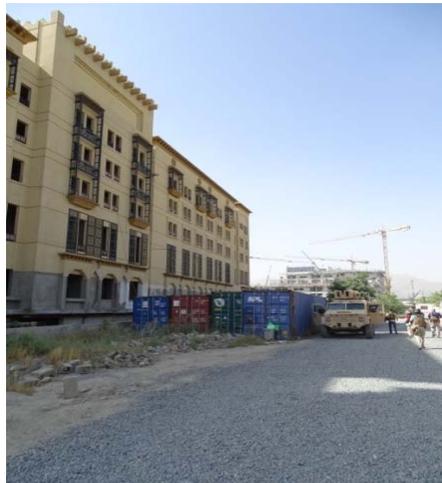
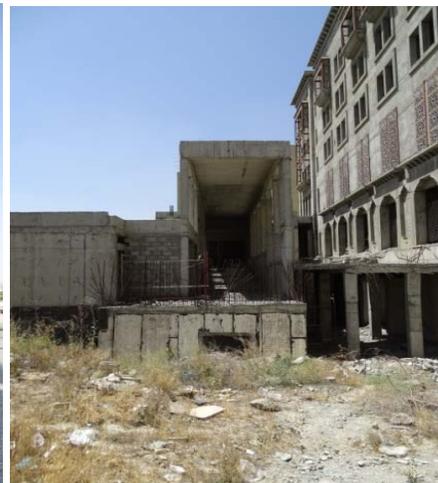
Land in front of the hotel has not been graded, landscaped, or paved. It is still being utilized as a construction staging area for 10-15 shipping containers, construction debris, and piles of fill dirt. Although the front of the hotel has decorative trim installed in and around the window openings, no permanently finished windows have been installed anywhere in the building. Permanent stairs have not been constructed at any hotel entrance. The only access into the building is a sheet-steel construction ramp at the southeast stairwell. Although the front and side walls of the hotel have a painted stucco finish, the building's exterior rear walls, side walls, roof domes, and roof structures are still rough unfinished concrete block or stucco. The existing painted stucco finish where installed is dirty. Cracks in the stucco and unfinished walls were noticed in the roof's domes, parapet walls, and auxiliary structures as well as in interior walls of the hotel.

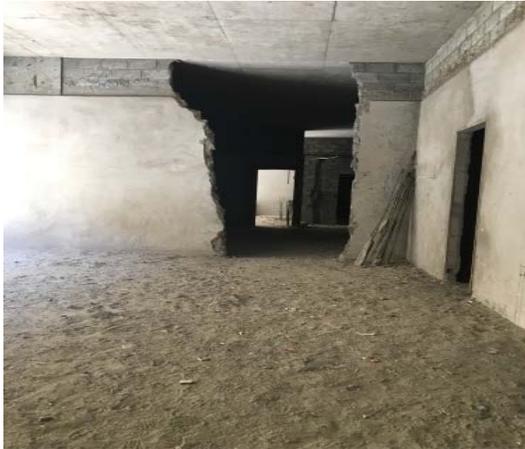
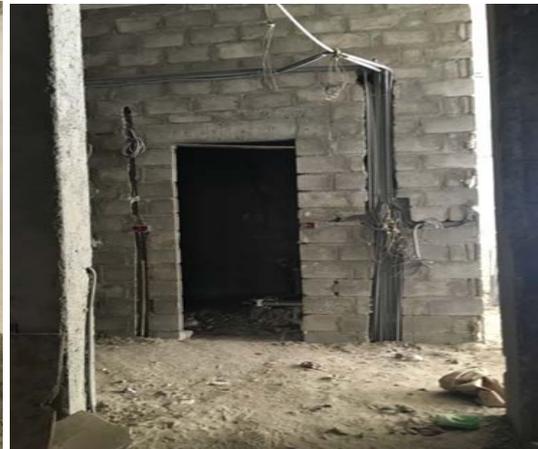
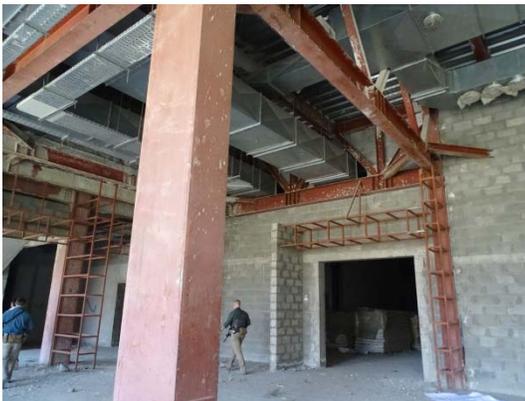
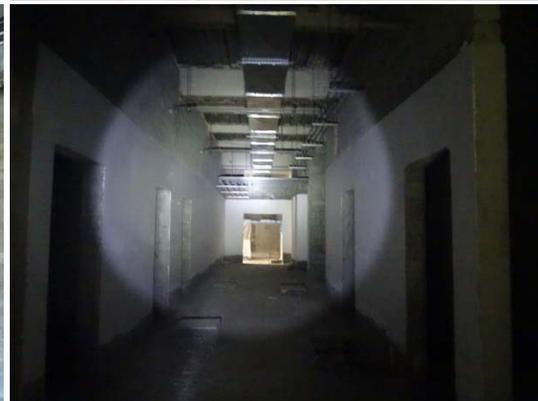
Some interior walls are coated with a primer coat of paint on plaster, but most are unfinished concrete block. The fire proofing on the red steel structural beams and columns is damaged or non-existent in many locations. (Fire proofing is a powdery coating on the steel beams and columns meant to keep the building intact longer during a fire, so more people can escape before the steel melts and the building collapses.) Ductwork, piping, and electrical wiring are installed at the “first fix” stage but none of these systems are close to complete. Many basement rooms are serving as storage for plastic electrical conduit, sheetrock for walls, barrels of unknown fluids, other construction materials and debris. Since most interior spaces were not connected to exterior wall openings providing natural light, not all of basement rooms could be examined. Construction lights are non-existent or not working.

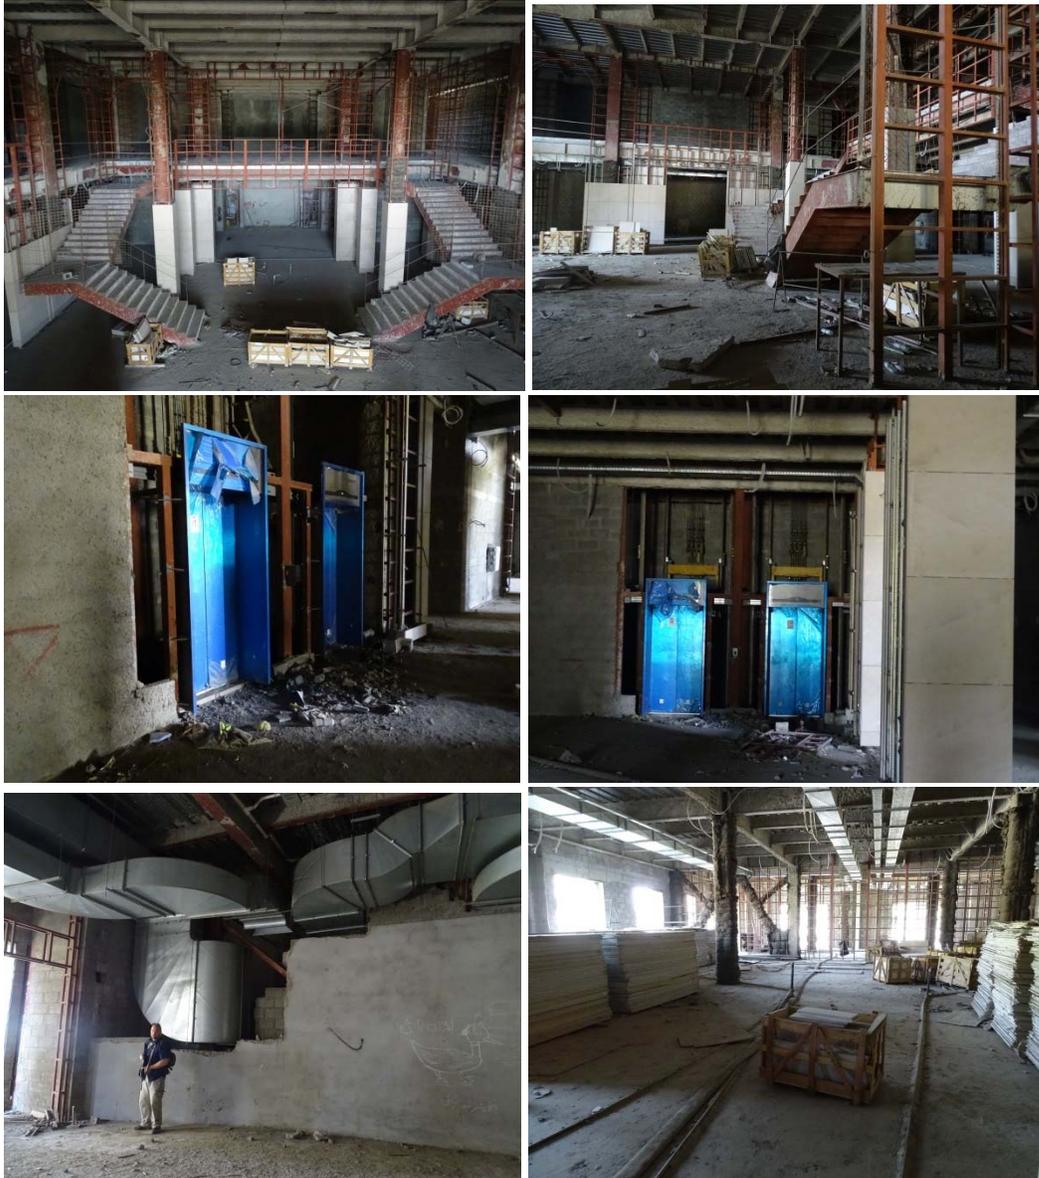
Interior courtyard stairs, steel framing, elevator doors covered with blue protective wrap ductwork, and tile work still need much progress before completion. Tile installation on columns, walls, and decorative metal framing for the interior courtyard has started, but the majority of framing and steel for columns, walls, and ceiling await the tile still stored in crates located throughout the ground floor. Fireproofing on the red steel beams and columns is partially complete and damaged. Some concrete block walls are plastered with a primer coat of paint, but the many stacks of sheet rock for the walls

are stored all throughout the ground floor. Cable trays, electrical conduit, sewer piping, ductwork, and small pipes for the air condition system are at the “first fix” stage of construction. Open ends of installed air conditioning duct HVAC ducts have allowed dust and contaminants to accumulate inside of the HVAC system for a long time, so the installed duct would have to be extensively cleaned or replaced before proceeding. Electrical wires and conduits hang freely from walls and ceilings.

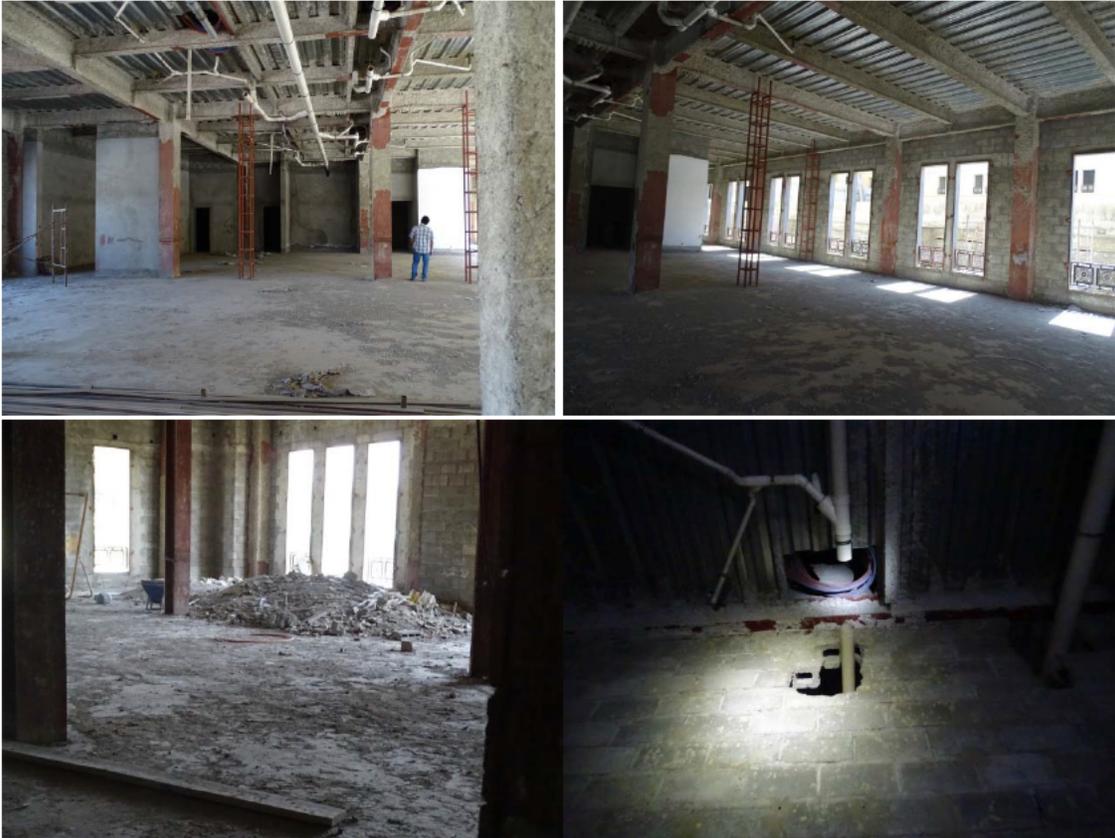
“First fix” sections of the sewer system piping are installed from the ceiling but not connected together. Bundles of electrical cables on upper floor were visible through holes cut into the ceiling above. The First floor does not show as much progress as the Ground floor and were missing similar cable trays, electrical wires, electrical conduit, ductwork, and small pipes for the air conditioning system. Large jagged holes have been cut into the walls where pipes pass through to different rooms.

Some sections of walls have been plastered. Fireproofing on the steel beams and columns is damaged or missing in many locations.

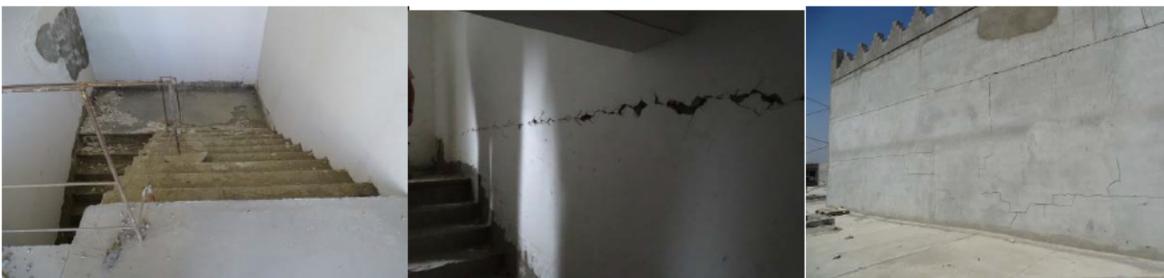
The stairs from the ground floor to the roof are uneven and unfinished with steps of different heights. Walls vary from partially plastered, unplastered concrete blocks, and partially constructed. Cracks were noted in the stairwell, the domes, parapet walls and rooftop rooms.

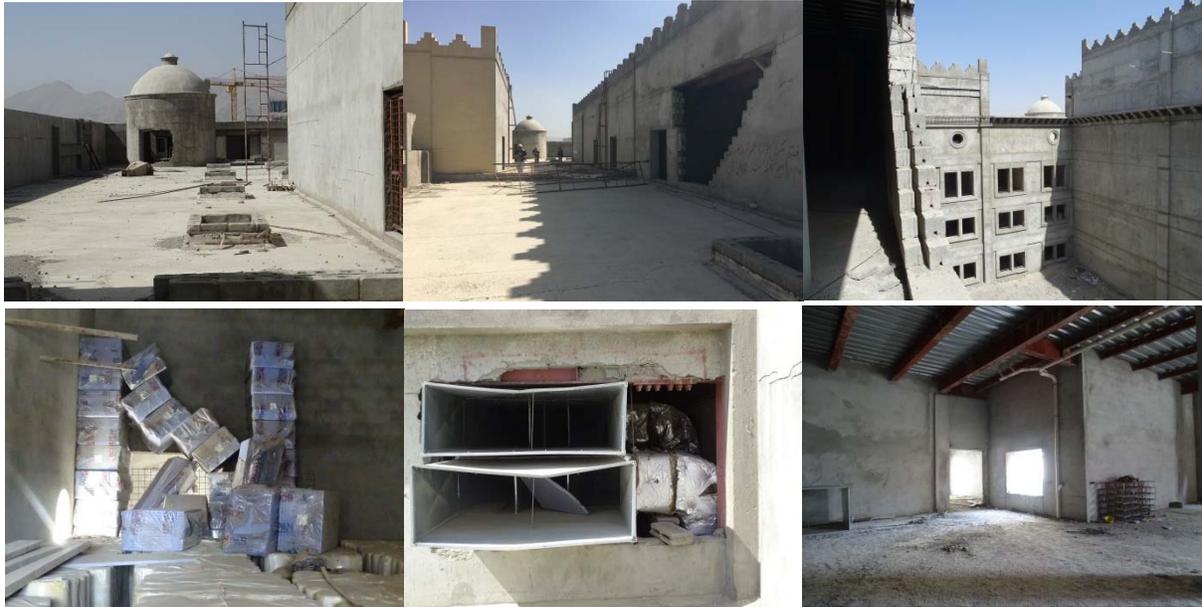
In roof domes and several rooftop rooms, large irregular sections walls are removed, as if to allow access for equipment, but there is no equipment. Large air conditioning ducts intended to connect to equipment have open ends exposed to dust, weather, and birds. Scaffolding, construction debris, abandoned tools, and bundles of stored roofing materials are located throughout the roof level

structures. The elevator cabins, hoist cables, and equipment are partially installed. Roof drain piping is installed in some locations.

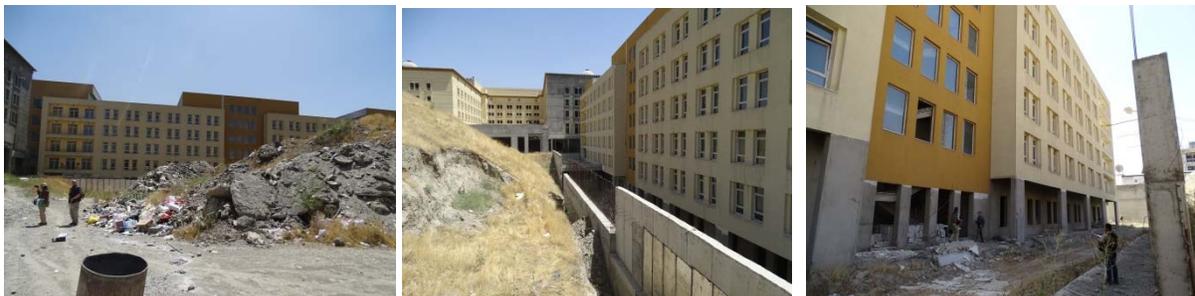
The front of the building shows that final grading and landscaping are far from starting. There is a large mound of fill dirt mixed with construction debris in the front of the Residence that obstructs the full view. The retaining wall in the back of the Residence has at least one section lacking concrete installation, and the waterproofing of the retaining wall is only half completed. The space between the retaining wall and the basement level is littered with large piles construction debris and weeds amidst stored materials including concrete block, granite slabs, ceramic and terrazzo tiles, and construction rebar framing waiting to be utilized.

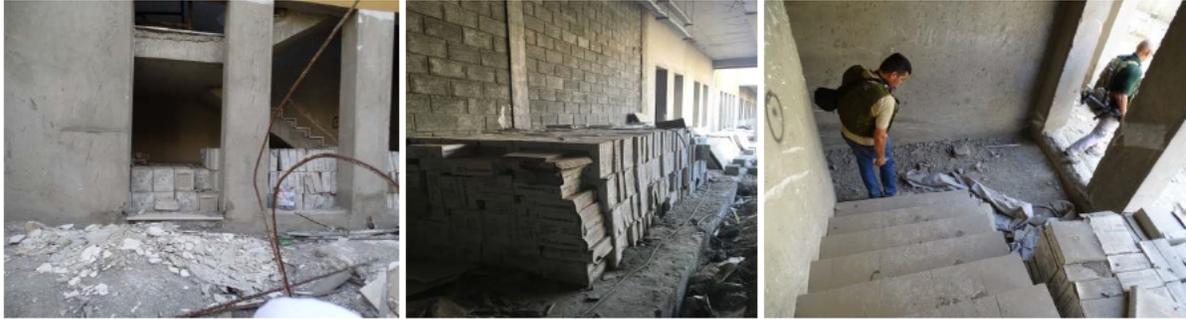
The Basement level has exposed roughly finished concrete walls, ceilings, and floors covered with dirt. Although plaster and paint have been applied to exterior walls above the basement level, the

basement walls and columns are completely unfinished. The basement level spaces are completely open to weather and used for sheltering concrete blocks, ceramic tiles, other construction material and piles of debris. Steps leading from the basement to the ground floor have terrazzo tile, but the surrounding walls and ceiling are rough unfinished concrete and there are no handrails; stairway is exposed to weather and not enclosed.

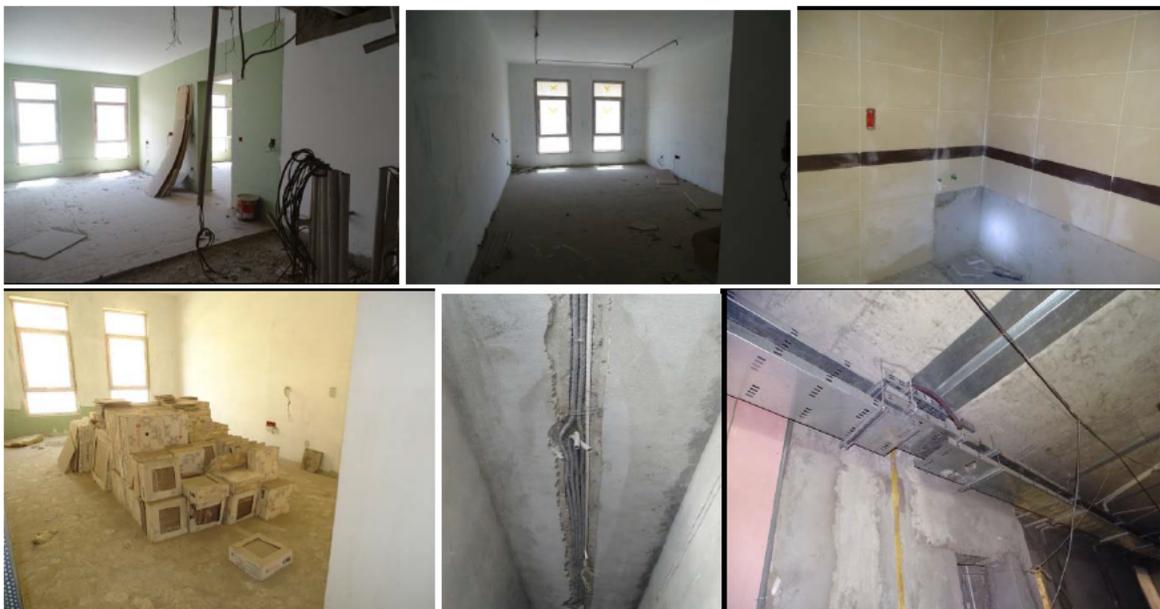
The stairway and corridor ceilings leading to the Ground have raggedly chipped out furrows to housing electrical conduits. Exterior windows are installed from the Ground Floor up, but interior trim and finish around the windows is not in place. A few rooms have a primed coat of paint on plaster or sheetrock walls. In some rooms the tile installation has started on the foyer and bathroom walls. Electrical wiring is hanging out of walls and conduits, which are far from ready for wall switches, outlets, or light fixtures. The “first fix” for electrical conduits, sewer and water piping, and air conditioning duct are visible in open mechanical spaces along the corridor and as well as in the residence rooms.

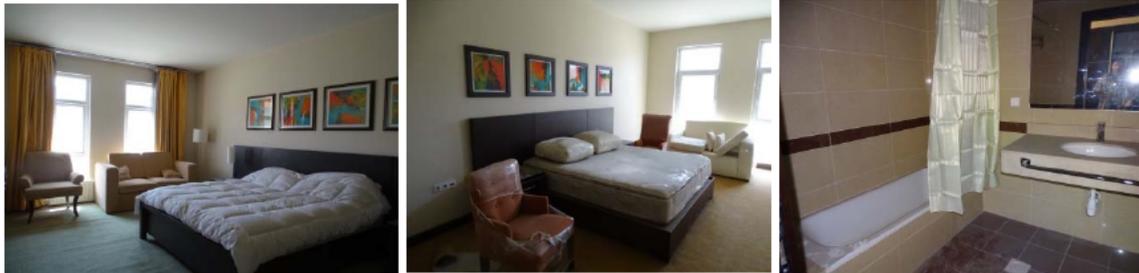
The only exceptions are two furnished “sample” rooms in the KGR to demonstrate the finished construction. These rooms looked deceptively complete but have none of the building systems or equipment to make them habitable (electricity, water, toilets, air conditioning, fire alarm, etc.). The finishes and contents were covered with thick layers of dust.

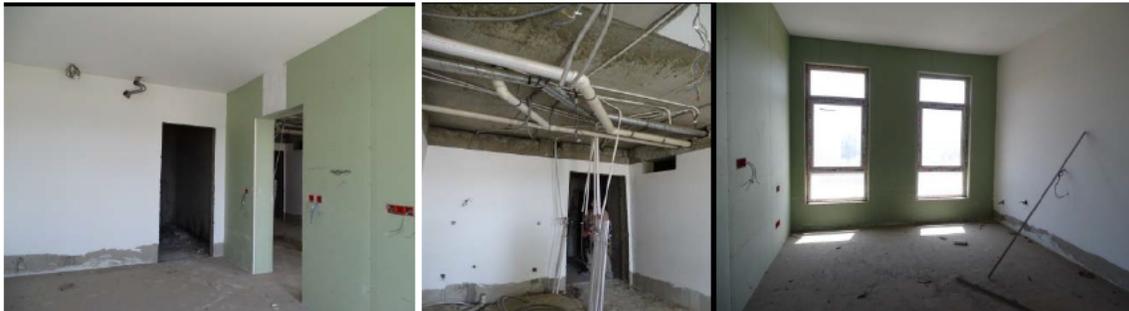
The First Floor was similar to the Ground floor with the exposed unconnected conduits hanging loosely from the ceiling, wiring hanging from wall penetrations, unfinished corridor and room walls (most without primer paint), exposed mechanical systems, and generous amounts of construction debris scattered throughout.

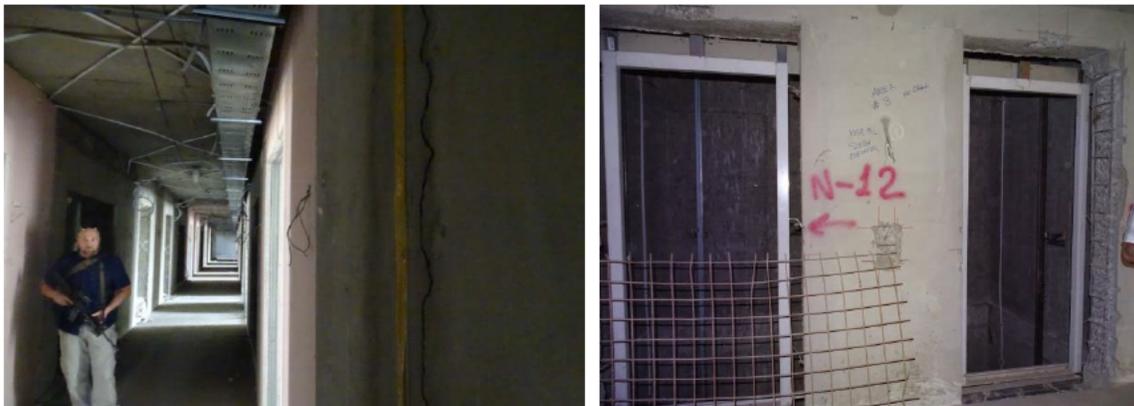
The corridor also shows the elevator installation is in the early stages of installation. Construction in the corridor is also still in the “first fix” stage.
